# WOOD DESTROYING PESTS AND ORGANISM INSPECTION REPORT

Building No. <b>43</b>	Street <b>Adam Way</b>	City <b>Atherton</b>	ZIP <b>94027</b>	Date of Inspection <b>2/26/2015</b>	Number of Pages <b>Page 1 of 8</b>
---------------------------	---------------------------	-------------------------	---------------------	--	---------------------------------------

General Description: <b>One story, single family wood framed residence with stucco and wood exterior.</b>	Inspection Tag Posted: <b>Water Heater Closet</b>
	Other Tags Posted: <b>Pacific Coast 08/06/11</b>

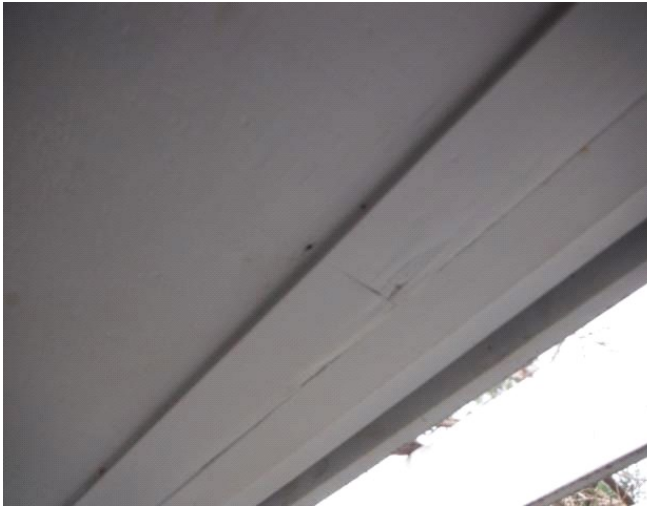
Picture 1

**1A.** FINDING: The soffit has been damaged by fungus at the front. (See Picture 1)

RECOMMENDATION: Remove and replace all the damaged wood members. If any damage is found to extend into any enclosed areas a supplemental report and bid will be issued.

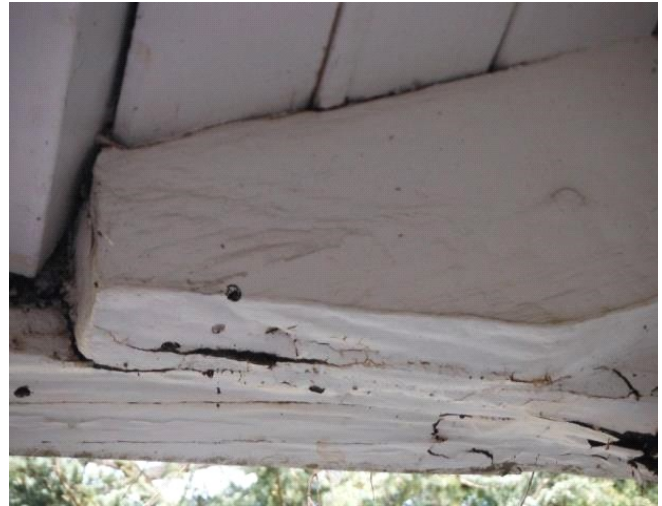
Picture 2

**1B.** FINDING: Fungus damage was noted to the barge rafter(s) as indicated on the diagram. (See Picture 2)

RECOMMENDATION: Remove and replace a section of the damaged barge(s) rafter to correct this condition. This bid includes replacement of the roof covering if disturbed by our repairs. If existing gutters need to be removed to perform the repairs then our bid also includes reinstallation of original gutters. If it becomes necessary or desirable to install new gutters this will be done only if authorized and at an additional cost. The guarantees on the roof covering are limited to the areas where the work was performed

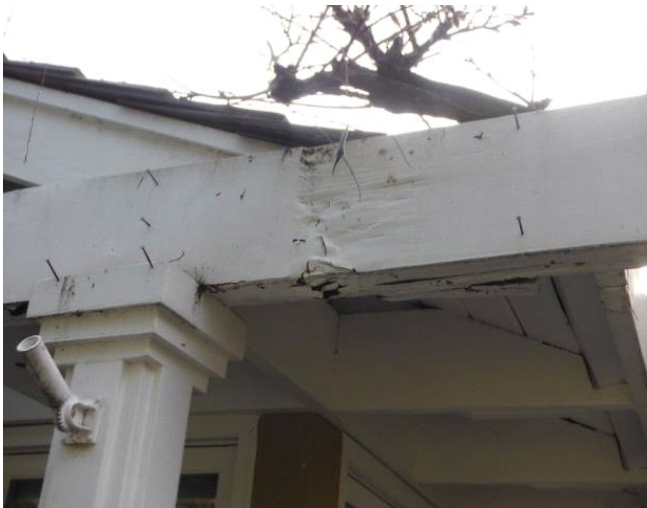
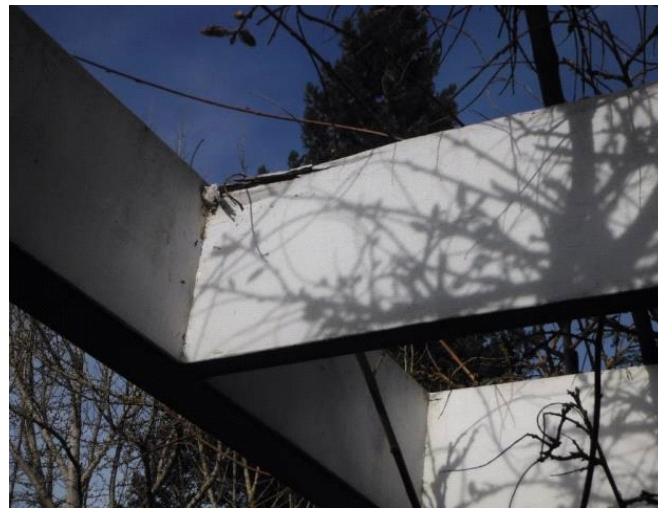
**1C.** FINDING: The wood members of the trellis have been damaged by fungus. (See Picture 3)  
(See Picture 4)

RECOMMENDATION: Remove and replace the structurally damaged wood members. If damage is found to extend into inaccessible areas, a supplemental report will be issued with any findings, recommendations, and/or bids.

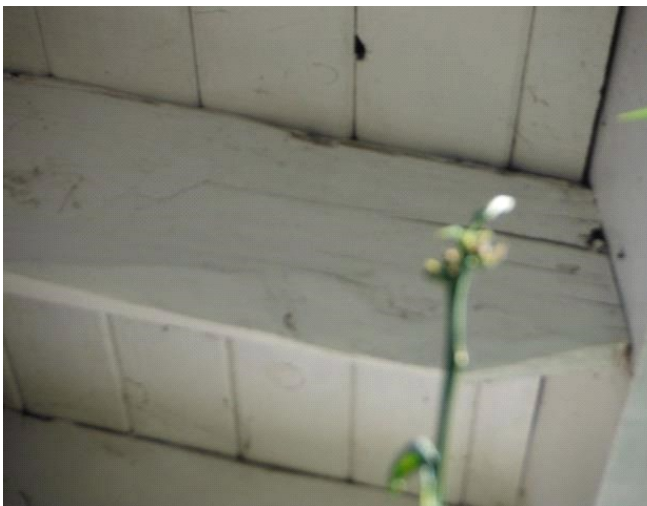
Picture 5

**1D. FINDING:** The rafter has been damaged by drywood termites at the rear side. (See Picture 5)

**1G. FINDING:** Infestation by drywood termites was noted at the exterior. (See Picture 5)

**1H. FINDING:** Drywood termite pellets were evident as noted in the above recommendation. (See Picture 5)

**RECOMMENDATION:** Remove and replace the damaged wood members to correct this condition. This bid includes replacement of the roof covering if disturbed by our repairs. If existing gutters need to be removed to perform the repairs then our bid also includes reinstallation of original gutters. If it becomes necessary or desirable to install new gutters this will be done only if authorized and at an additional cost. The guarantees on the roof covering are limited to the areas where the repairs were performed

**RECOMMENDATION:** Drill and treat the infested areas with the registered termiticide Termidor SC (Fipronil:5-amino-1-(2,6-dichloro-4-(trifluoromethyl) phenyl)-4-((1,8,5)-trifluoromethyl)sulfinyl)-1-H-pyrazole-3-carbonitrile in a liquid formulation. NOTE: As drywood termites are a non-earth dwelling species, guarantees are limited to treated wood members only. NOTE: In order to perform this treatment the property must be vacated during the treatment and three hours after the treatment is performed. If any concealed pipes, conduit or electrical wiring or other facilities are drilled into during the course of performing this item it will be the owners responsibility and cost to repair these items.

**RECOMMENDATION:** Remove and/or mask over all accessible termite pellets. It is possible for the drywood termite pellets to sift down or reappear in these areas where they have been masked over.

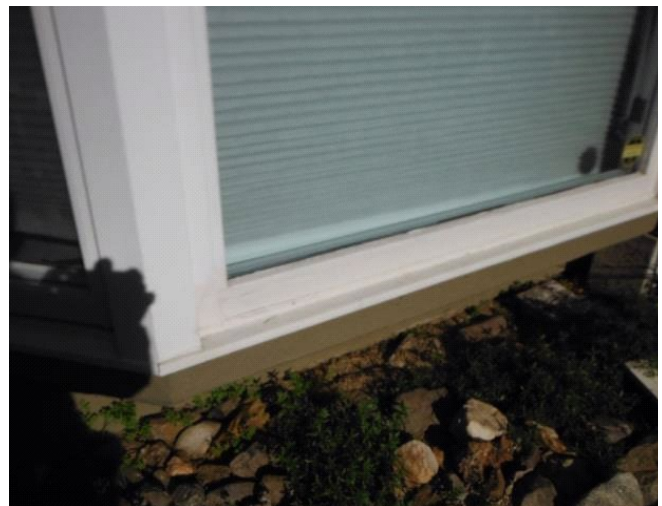
Picture 6

**1E. FINDING:** The wooden window sash has been damaged by fungus at the rear side. (See Picture 6)

**RECOMMENDATION:** Replace the entire window sash with a new wooden window sash. Please note that in order to complete this item, there could be a two week delay in getting the new windows milled. At the owners request a bid can be supplied for replacing this window with an energy efficient window.

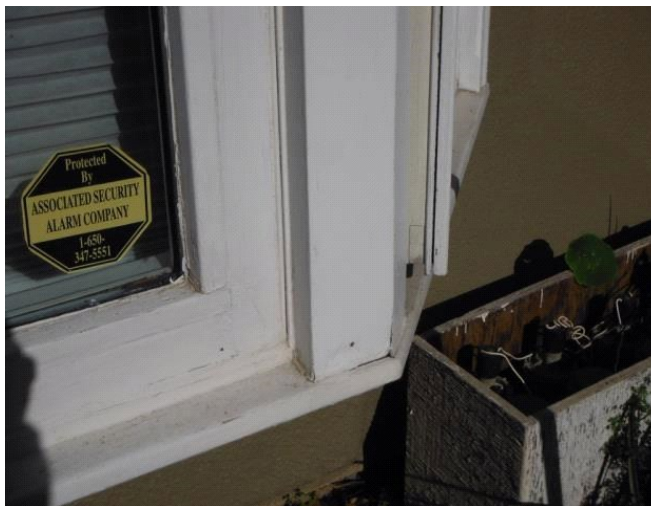
Picture 7

**1F. FINDING:** The window trim has been damaged by fungus at the rear side. (See Picture 7)

**RECOMMENDATION:** Remove and replace all the damaged wood members. If any damage is found to extend into any enclosed areas a supplemental report and bid will be issued.
